# Medical Devices: The Therac-25\*

Nancy Leveson  
University of Washington

## 1 Introduction

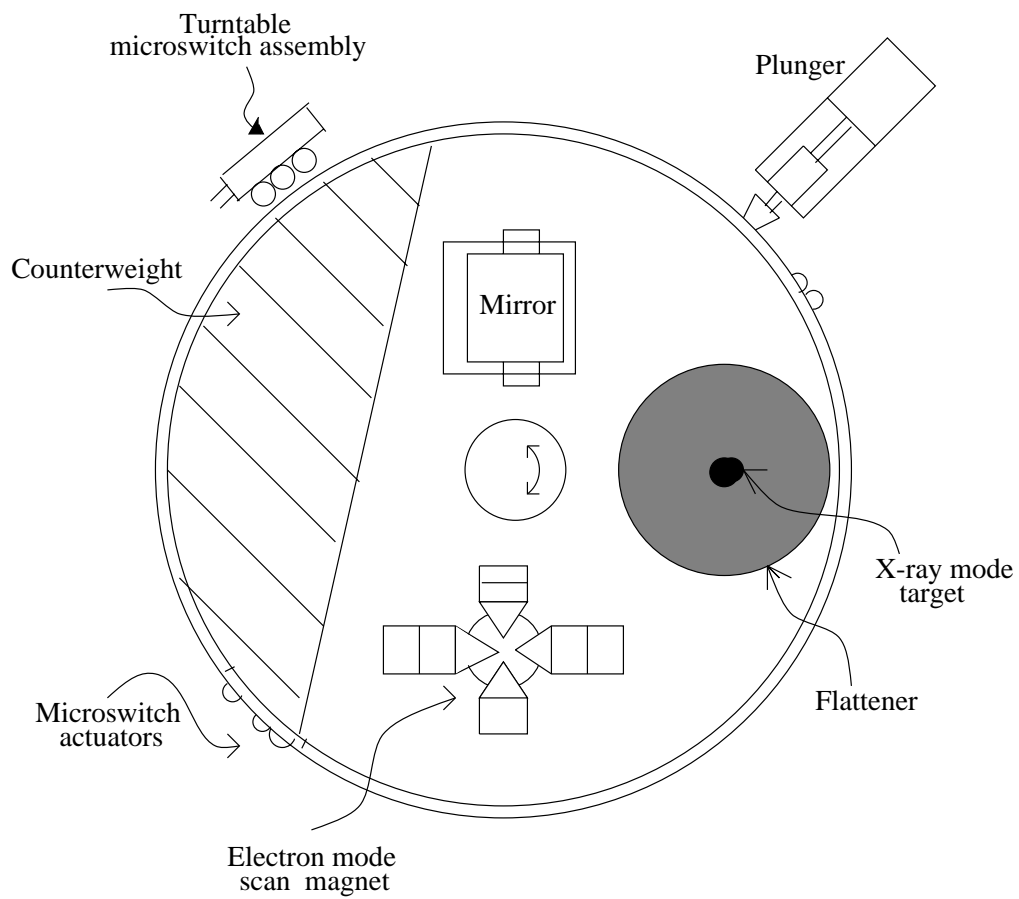
Figure 1: Upper turntable assembly.

**Turntable Positioning.** The Therac-25 turntable design plays an important role in the accidents. The upper turntable (see Figure 1) rotates accessory equipment into the beam path to produce two therapeutic modes: electron mode and photon mode. A third position (called the field light position) involves no beam at all, but rather is used to facilitate correct positioning of the patient. Because the accessories appropriate to each mode

are physically attached to the turntable, proper operation of the Therac-25 is heavily dependent on the turntable position, which is monitored by three microswitches.

The computer senses and controls turntable position by reading a 3-bit signal about the status of three microswitches in the turntable switch assembly. Essentially, AECL determined that a 1-bit error in the microswitch codes (which could be caused by a single open-circuit fault on the switch lines) could produce an ambiguous position message to the computer. The problem was exacerbated by the design of the mechanism that extends a plunger to lock the turntable when it is in one of the three cardinal positions: The plunger could be extended when the turntable was way out of position, thus giving a second false position indication. AECL devised a method to indicate turntable position that tolerated a 1-bit error so that the code would still unambiguously reveal correct position with any one microswitch failure.

The modifications specified in the Symonds report included redesigning the microswitch and changing the way the computer handled malfunction conditions. In particular, treatment was to be terminated in the event of a dose-rate malfunction, giving a treatment “suspend.” This change would have removed the option to proceed simply by pressing the  $\textcircled{P}$  key. The report also made recommendations regarding collimator test procedures and message and command formats. A November 8, 1985 letter, signed by the director of the Canadian RPB, asked that AECL make changes to the Therac-25 based on the Symond’s report “to be in compliance with the RED act.”

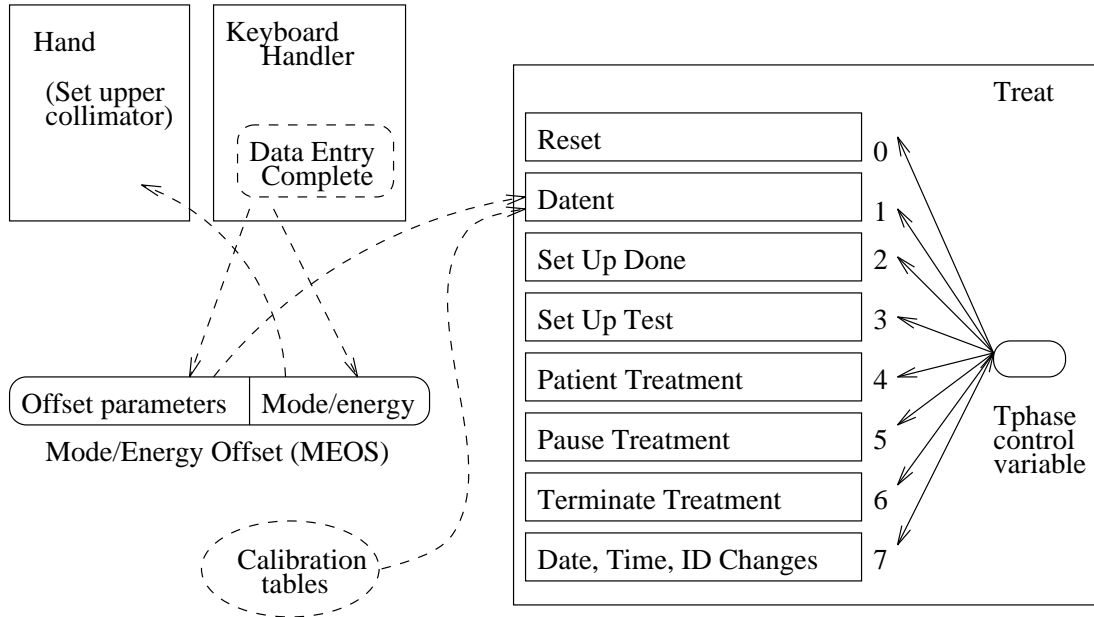
Figure 3: Tasks and subroutines in the code blamed for the Tyler accidents.

The treatment monitor task (Treat) controls the various phases of treatment by executing its eight subroutines. The treatment phase indicator variable (Tphase) is used to determine which subroutine should be executed (Figure 3). Following the execution of a particular subroutine, Treat reschedules itself.

But this is not the only problem. Upon exit from the Magnet subroutine, the data entry subroutine (Datent) checks the Data Entry Complete variable. If it indicates that data entry is complete, Datent sets Tphase to 3 and Datent is not entered again. If it is not set, Datent leaves Tphase unchanged, which means it will eventually be rescheduled. But the Data Entry Complete variable only indicates that the cursor has been down to the command line, not that it is still there. A potential race condition is set up. To fix this, AECL introduced another shared variable controlled by the keyboard handler task that indicates the cursor is not positioned on the command line. If this variable is set, then prescription entry is still in progress and the value of Tphase is left unchanged.

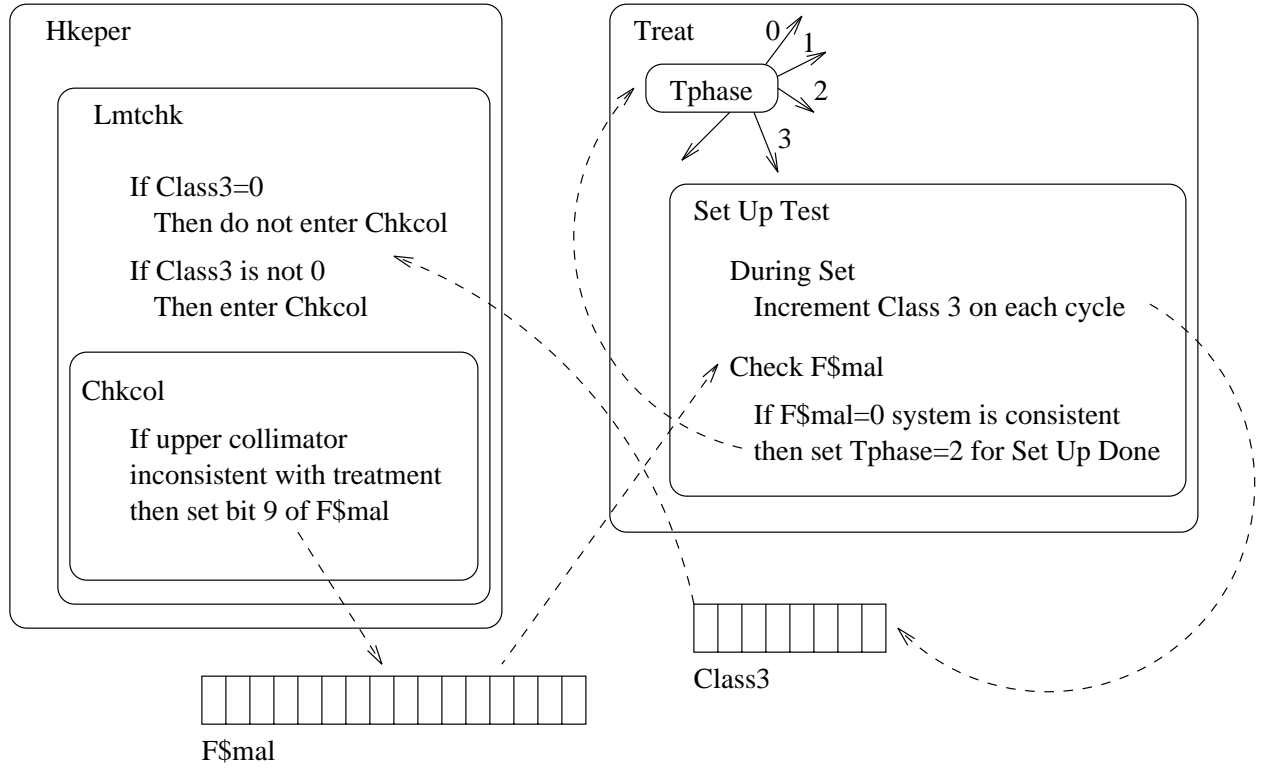
Figure 4: The Yakima software flaw.

The second Yakima accident was again attributed to a type of race condition in the software — this one allowed the device to be activated in an error setting (a “failure” of a software interlock). The Tyler accidents were related to problems in the data-entry routines that allowed the code to proceed to Set Up Test before the full prescription had been entered and acted upon. The Yakima accident involved problems encountered later in the logic after the treatment monitor Treat reaches Set Up Test.

The Therac-25’s field light feature allows very precise positioning of the patient for treatment. The operator can control the machine right at the treatment site using a small hand control that offers certain limited functions for patient setup, including setting gantry, collimator, and table motions.

The overexposure occurred when the operator hit the “set” button at the precise moment that Class3 rolled over to zero. Thus, Chkcol was not executed and F\$mal was not set to indicate that the upper collimator was still in the field-light position. The software turned on the full 25 MeV without the target in place and without scanning. A highly concentrated electron beam resulted, which was scattered and deflected by the stainless

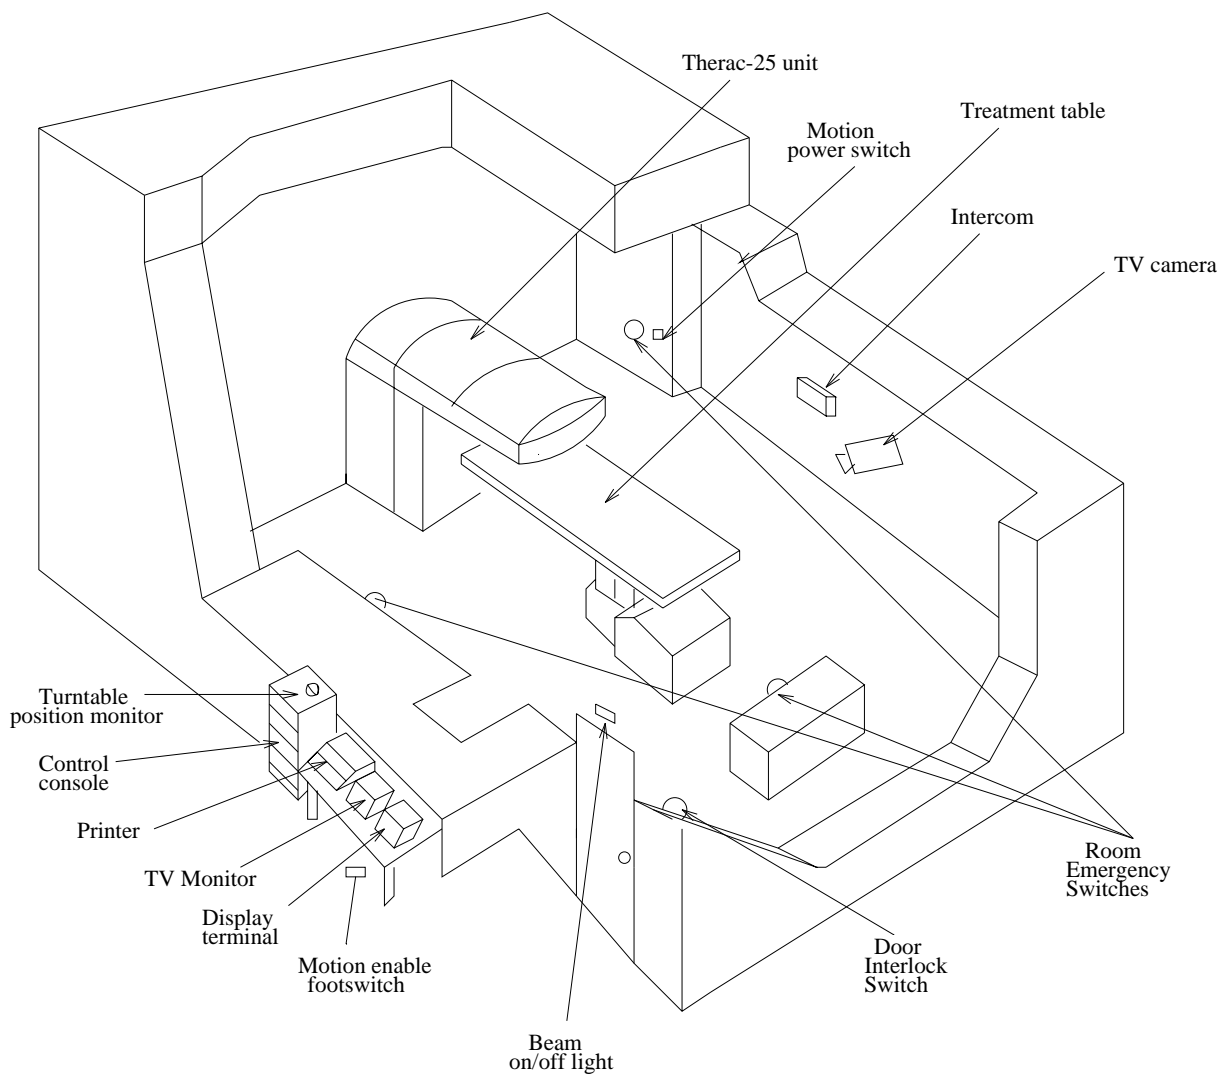
Figure 5: A typical Therac-25 facility after the final CAP.

Figure 5 shows a typical Therac-25 installation after the CAP changes were made.

- Beam-on will be prevented if the turntable is in the field light or any intermediate position.
- Cryptic malfunction messages will be replaced with meaningful messages and highlighted dose-rate messages.

- The known software problems associated with the Tyler and Yakima accidents will be fixed.
- The manuals will be fixed to reflect the changes.
