An Investigation of the Therac-25 Accidents

Nancy G. Leveson, University of Washington

Clark S. Turner, University of California, Irvine

A thorough account of the Therac-25 medical electron accelerator accidents reveals previously unknown details and suggests ways to reduce risk in the future.

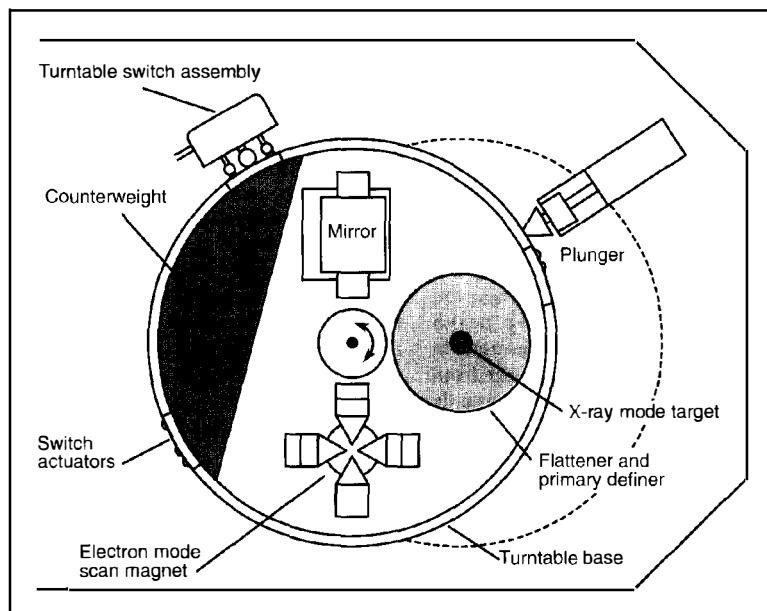
Figure B. Upper turntable assembly.

croswitch codes (which could be caused by a single open-circuit fault on the switch lines) could produce an ambiguous position message for the computer.

hazard of dual-mode machines: If the turntable is in the wrong position, the beam flattener will not be in place.

No accelerator beam is expected in the field-light position. A stainless steel mirror is placed in the beam path and a light simulates the beam. This lets the operator see precisely where the beam will strike the patient and make necessary adjustments before treatment starts. There is no ion chamber in place at this turntable position, since no beam is expected.

cate turntable position that tolerated a 1-bit error: The code would still unambiguously reveal correct position with any one microswitch failure.

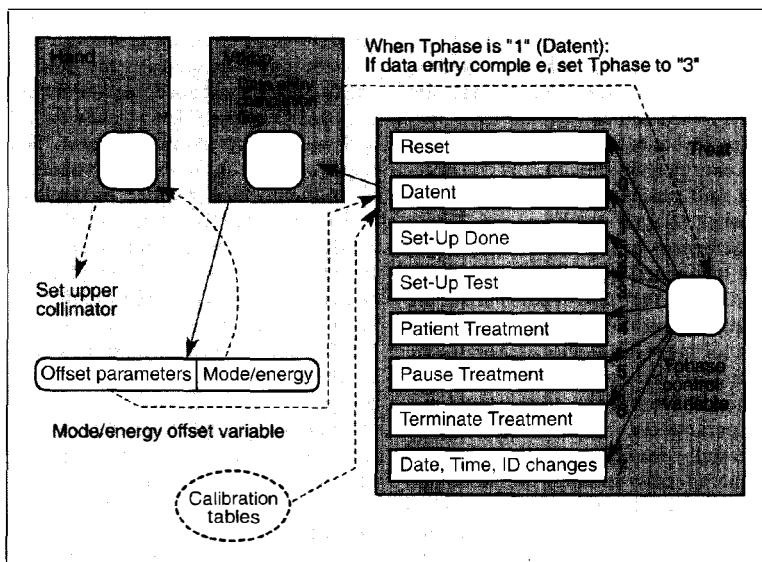
Figure 2. Tasks and subroutines in the code blamed for the Tyler accidents.

As described in the sidebar on Therac-25 software development and design, the treatment monitor task (Treat) controls the various phases of treatment by executing its eight subroutines (see Figure 2). The treatment phase indicator variable (Tphase) is used to determine which subroutine should be executed. Following the execution of a particular subroutine, Treat reschedules itself.

One of Treat's subroutines, called Datent (data entry), communicates with the keyboard handler task (a task that runs concurrently with Treat) via a

shared variable (Data-entry completion flag) to determine whether the prescription data has been entered. The keyboard handler recognizes the completion of data entry and changes the Data-entry completion variable to denote this. Once the Data-entry completion variable is set, the Datent subroutine detects the variable's change in status and changes the value of Tphase from 1 (Data Entry) to 3 (Set-Up Test). In this case, the Datent subroutine exits back to the Treat subroutine, which will reschedule itself and begin execution of the Set-Up Test subroutine. If the Data-entry completion variable has not been set, Datent leaves the value of Tphase unchanged and exits back to Treat's main line. Treat will then reschedule itself, essentially rescheduling the Datent subroutine.

Upon exit from the Magnet subroutine, the data-entry subroutine (Datent) checks the data-entry completion variable. If it indicates that data entry is complete, Datent sets Tphase to 3 and Datent is not entered again. If it is not set, Datent leaves Tphase unchanged, which means it will eventually be rescheduled. But the data-entry completion variable only indicates that the cursor has been down to the command line, not that it is still there. A potential race condition is set up. To fix this, AECL introduced another shared variable controlled by the keyboard handler task that indicates the cursor is not positioned on the command line. If this variable is set, then prescription entry is still in progress and the value of Tphase is left unchanged.

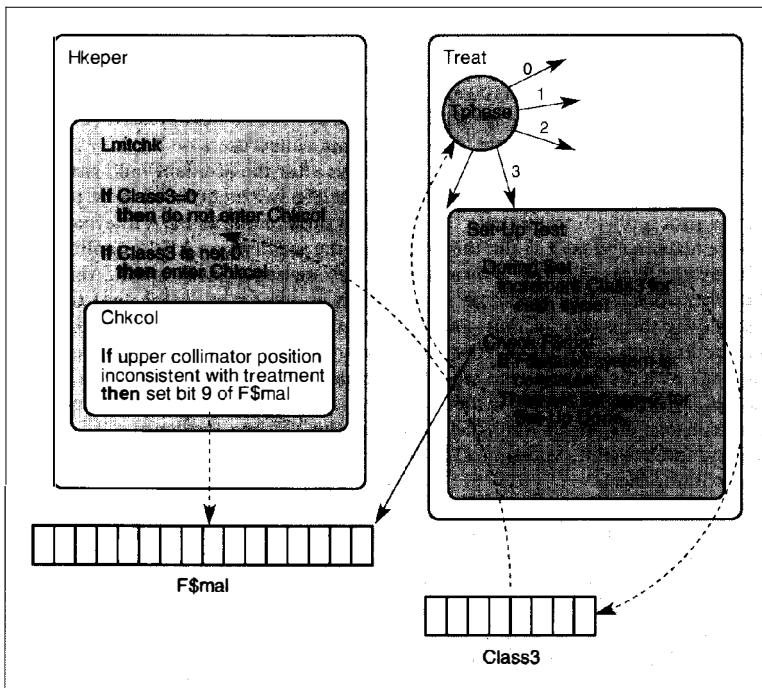
Figure 4. Yakima software flaw.

The second Yakima accident was again attributed to a type of race condition in the software — this one allowed the device to be activated in an error setting (a "failure" of a software interlock). The Tyler accidents were related to prob-

lems in the data-entry routines that allowed the code to proceed to Set-Up Test before the full prescription had been entered and acted upon. The Yakima accident involves problems encountered later in the logic after the treatment monitor Treat reaches Set-Up Test.
